# Manhole Inspection Summary

Manhole # S350\_\_077MH

Insp Date: 1/23/08 10:55 AM

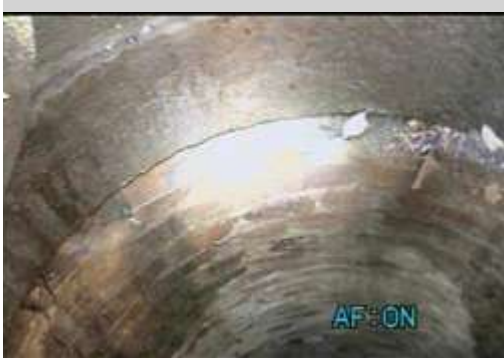
Defect 1

Offset: **1** (in.)

frame offset

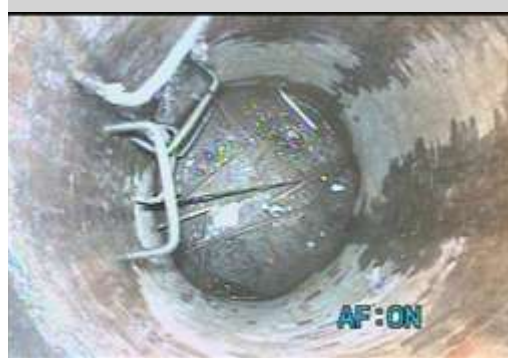
Defect 2

Condition: ☐ Sound ☐ Cracked ☐ Root Intrusion ☐ Deteriorated ☐ Leaks ☒ **Debris**

Channel Debris

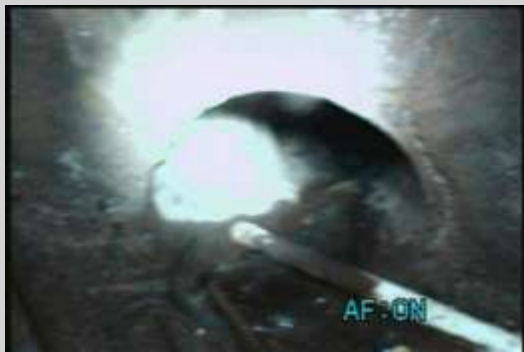
12 O'Clock Outflow

8 in. Circular Gravity Sewer  
Pipe Out @ 12 O'Clock

Deposits: ☐ None ☐ Mud ☐ Sludge ☒ **Debris** ☐ Grease

Silt Depth: **1** (in.) Deposits Extent: **Light**
